Installation Notes for Thuraya IP firmware 1.0.7.2

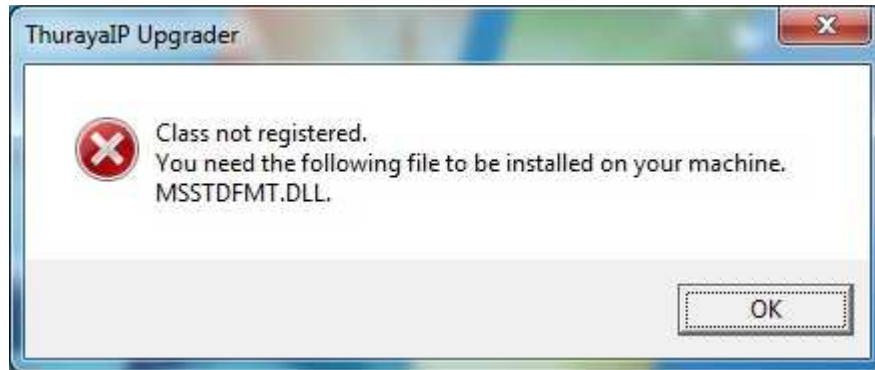
We have observed few cases of installation failures in some Windows 7 systems with the below pop up error message which mention about MSSTDFMT.DLL file.

In case you encounter this problem, please follow the below instructions:

- 1) Download MSSTDFMT.DLL file from Thuraya IP webpage
<http://www.thuraya.com/thuraya-ip-upgrader>
- 2) Copy MSSTDFMT.DLL into C:\windows\system\
- 3) Go to RUN and type "regsvr32 c:\windows\system\msstdfmt.dll"
- 4) Now reinstall the upgrader application
